Condition & Value Survey

September 12, 2018

Juniper

The subject of this survey is a Friendship Sloop built in 1962 [Figure 10.1].

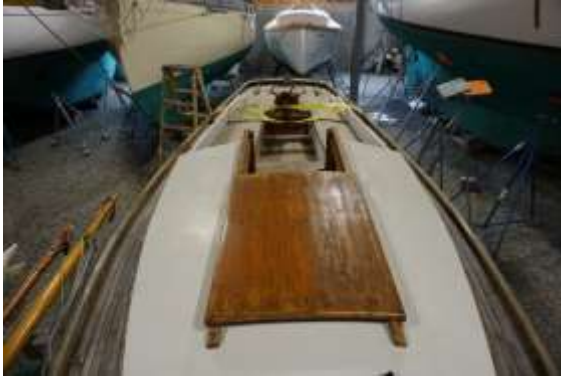
- The cosmetics are poor on deck and topsides, deferred maintenance evident [Figure 10.17]&[Figure 10.7]
- The caulked deck leaks, very moist below deck & fastener bungs are loose

Figure 10.7 Deck view looking aft

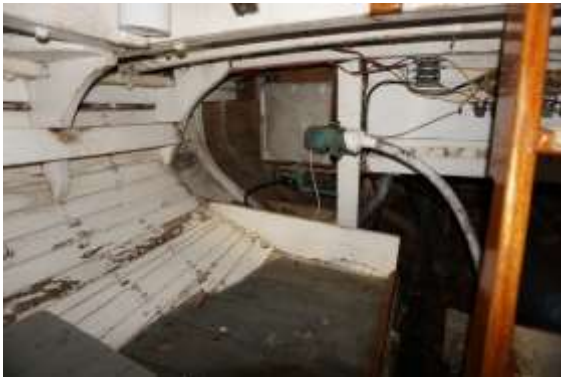
Figure 10.9 Looking aft in cabin, note old gas tank

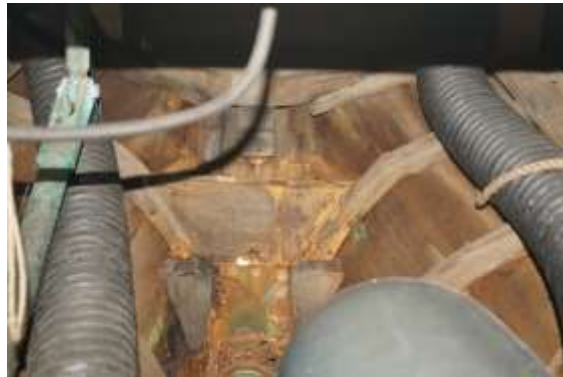
- Broken frames in aft tuck of bilge, may have been broken a long time [Figure 10.10]
- Some sections of the rails are coming apart

Figure 10.10 Looking aft above shaft log, note broken frames

- 1 Install drain plug prior to launch
- 1 Putty/caulk bottom plank & topsides seams where required
- 2 Refasten bottom planking
- 2 Repair rot spots in keel
- 2 Make deck watertight to avoid fresh water intrusion
- 2 Repair broken frames aft at tuck of bilge
- 2 Repair loose/broken sections of rails
- 3 Prep/putty/paint wood surfaces to reduce weathering & to avoid water intrusion

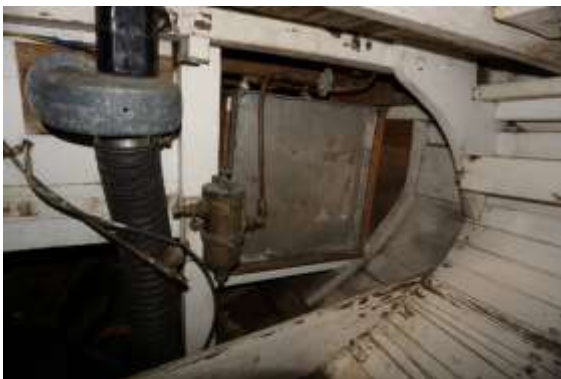
The engine has been removed. The rest of the engine components/accessories should be removed including the propeller shaft, hoses, blower etc. The gas tanks should be removed as a safety consideration [Figure 10.11]. The shaft log should be plugged after the shaft removal. All unused seacocks should be properly plugged, or the seacocks should be removed, and the planking properly plugged [Figure 10.15].

Figure 10.11 Old gas tank & engine components

- 1 Remove old gas tanks & old engine accessories
- 1 Remove propeller shaft & plug hole in shaft log
- 1 Properly plug seacocks or remove seacocks and plug plank holes
- 1 Install solar panel, appropriately sized battery & 12-volt bilge pump prior to launch
- 1 Re-work cockpit drains with proper hoses and install seacocks
- 1 Tighten/replace loose bolt in steering gear
- 3 Have mechanic inspect trailer

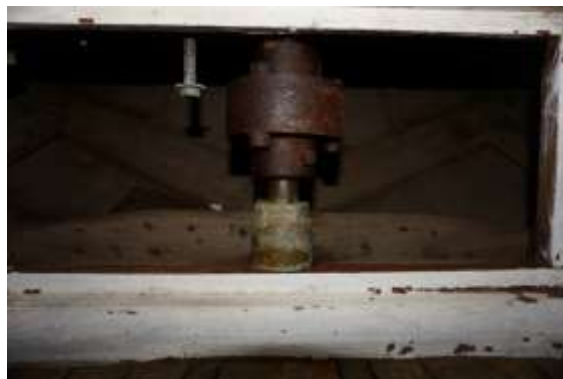
A bolt is loose on the steering gear [Figure 10.12].

Figure 10.12 Loose bolt on steering gearbox

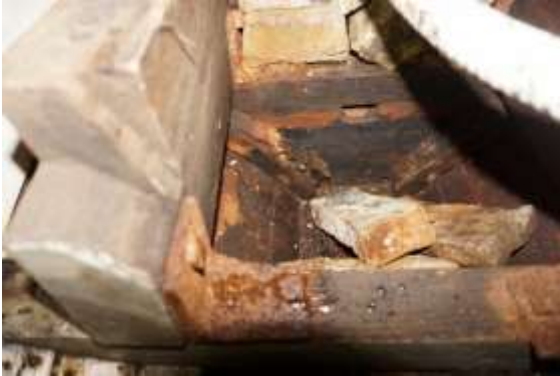
Ceiling planking on the interior of the vessel obstructed inspection of many frames [Figure 10.8]. Most frames ends are serviceable, some are deteriorated, while others are in the beginning stages of deterioration [Figure 10.13].

Figure 10.13 Poor frame end inboard of engine beds

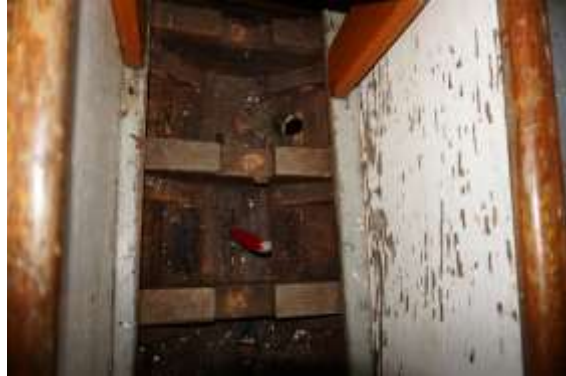
- Rotten spot on top of keel aft, just forward of engine beds [Figure 10.14], will need repairs/replacement in the near future.
- The drain plug in the garboard is not installed

Figure 10.14 Rot pocket in top of keel

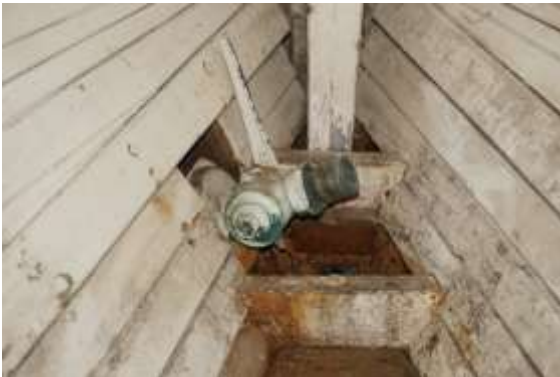
Figure 10.15 Unused seacock

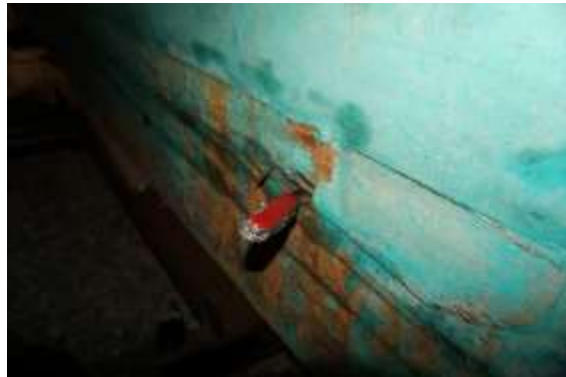
- There is a rotten spot on the port side of the keel just forward of the rudderpost [Figure 10.16] repairs will be necessary soon, an older small repair was noted in this area

Figure 10.16 Rot pocket in keel

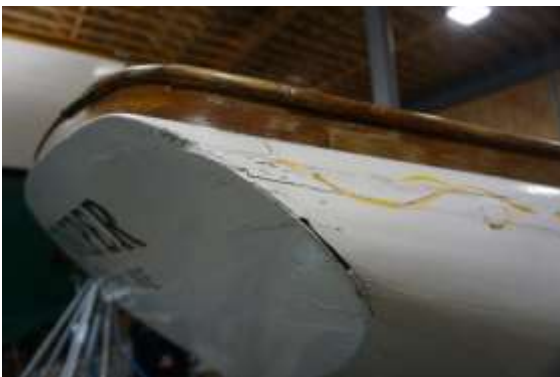
The hull is fair to the eye with no deformities noted on the hull exterior. A plank butt on the port side garboard is set in a bit from the surrounding planks, percussion testing of this area brought good reports from the hammer [Figure 10.22]. The hull and topside planking also brought good reports from percussion testing, some of the hull planking has dried out in areas [Figure 10.17].

Figure 10.17 Dry planking on transom hood-ends

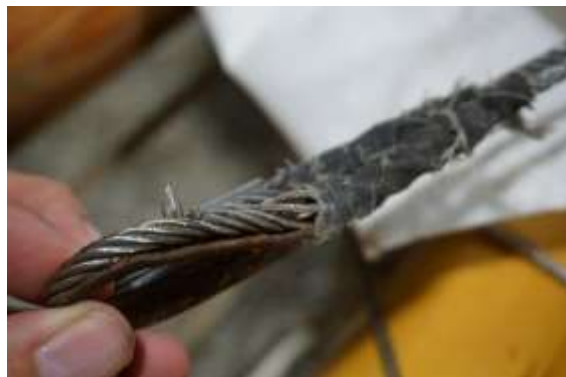
The mast is serviceable, no rot was noted. The jaws on the boom and gaff are constructed crudely but functional. The standing rigging is worn [Figure 10.18] and generally poorly constructed using cable clamps in areas [Figure 10.20] and needs replacement prior to commissioning. Wood laminations in the bowsprit are separating [Figure 10.19].

Figure 10.18 Shroud in poor condition

- 1 Replace shrouds & stays on standing rigging
- 1 Repair wood delamination in bowsprit
- 3 Re-work gaff and boom jaws for a better appearance

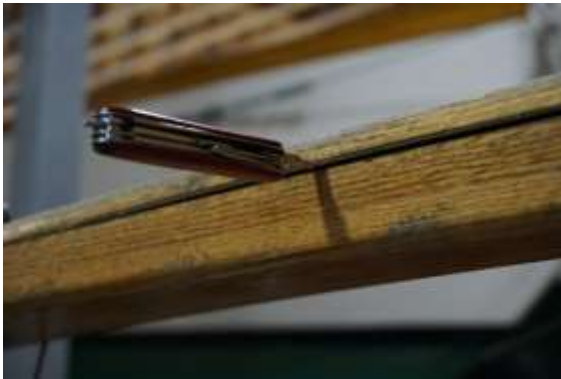
Figure 10.19 Bowsprit laminate compromised

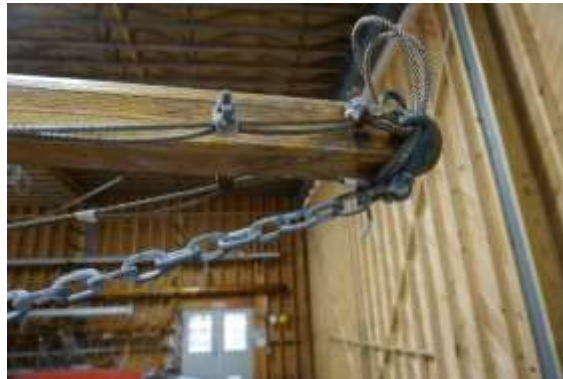
Figure 10.20 Cable clamps on bowsprit rigging

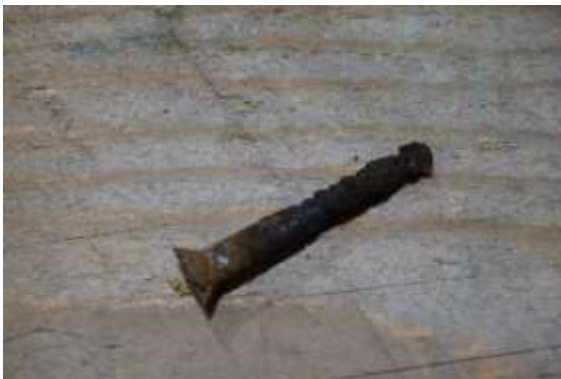
- Three galvanized screws were attempted to be removed below waterline. The heads of two fasteners were corroded and could not be removed. One fastener was removed and found to be in poor condition [Figure 10.21], refastening of bottom planks is necessary

Figure 10.21 Galvanized fastener in poor condition

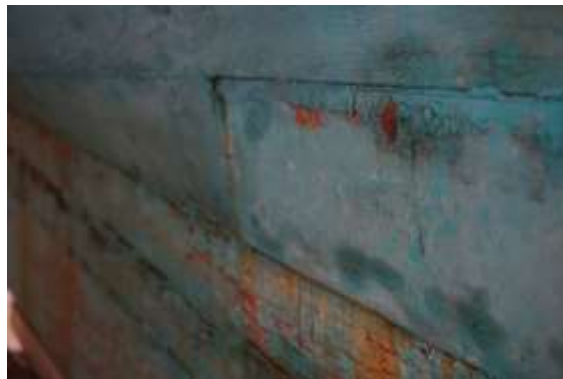
Figure 10.22 Set in garboard plank at butt
