Condition & Value Survey

September 12, 2018

Juniper

The subject of this survey is a Friendship Sloop built in 1962 [Figure 10.1].

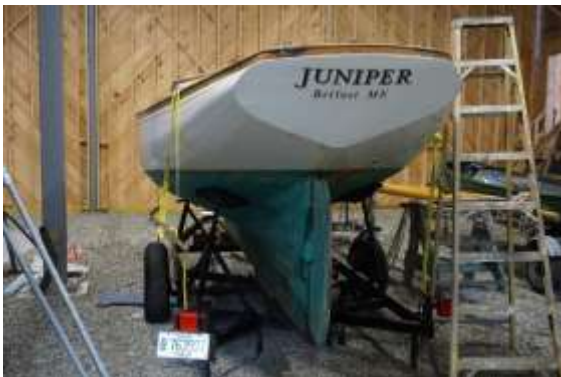
Figure 10.3 View of transom

The vessel sits nicely on the trailer [Figure 10.3], some surface corrosion was noted. The tires appear serviceable. The wheel bearings were not checked. Trailer VIN # 1T9S191NOTN013013
Serial # TY/094

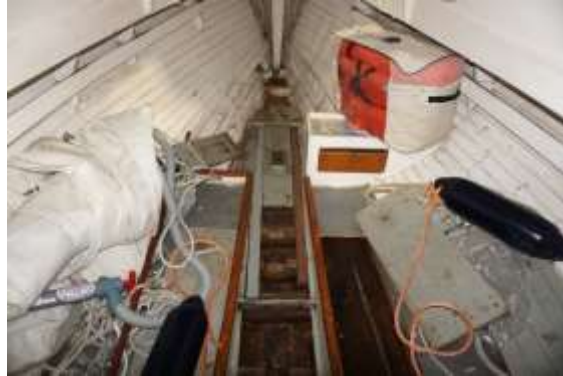
Figure 10.8 Looking forward in cabin

Ceiling planking on the interior of the vessel obstructed inspection of many frames [Figure 10.8]. Most frames ends are serviceable, some are deteriorated, while others are in the beginning stages of deterioration [Figure 10.13].

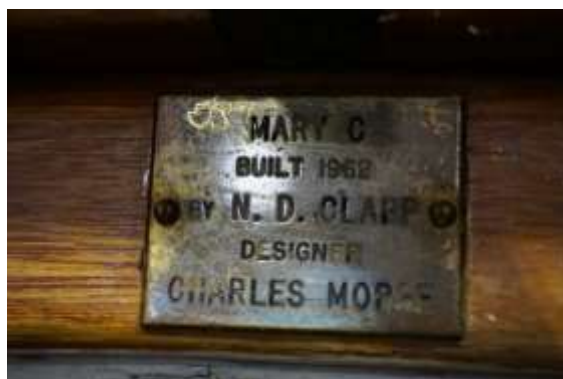
Figure 10.24 Builders plaque

Builder: N.D. Clapp [Figure 10.24]
